Inspection Report

Big Sky Home Inspection, LLC
Michael J Gage
TREC Lic. #20903

555 Sample Lane
Austin, TX 78734

PROPERTY INSPECTION REPORT

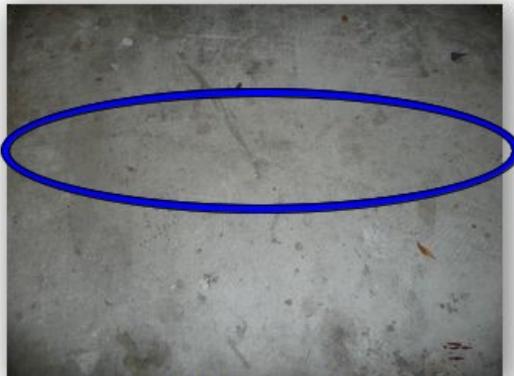
- Hydration cracks were observed on the floor of the garage . Hydration cracks are normal in a concrete slab and are generally considered to be cosmetic defects. However, all cracks should be monitored for any changes or movement.

Hydration crack

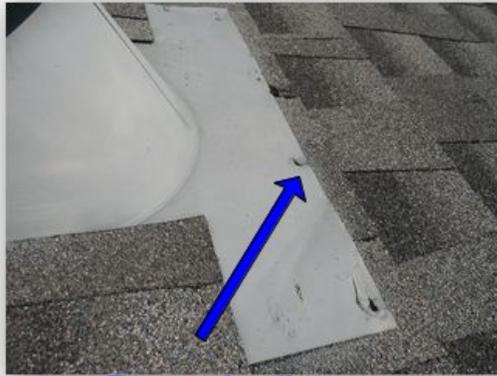
- Exposed nails were present at various flashing and roof coverings. These nails should be caulked to prevent deterioration or possible leaks. See right side of the home as example.

Exposed nails

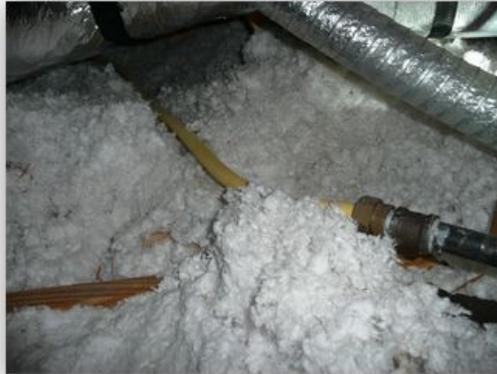
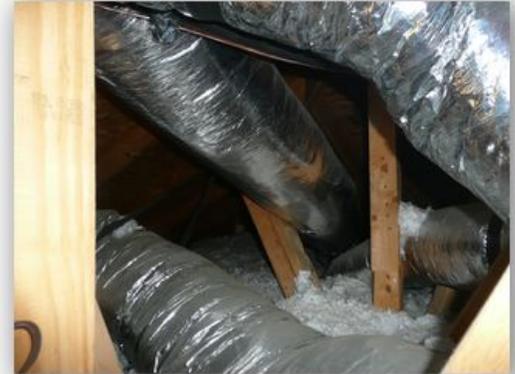
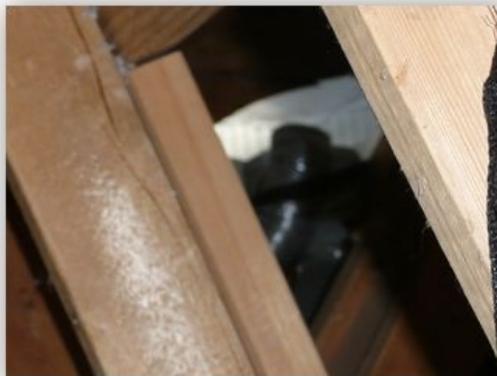
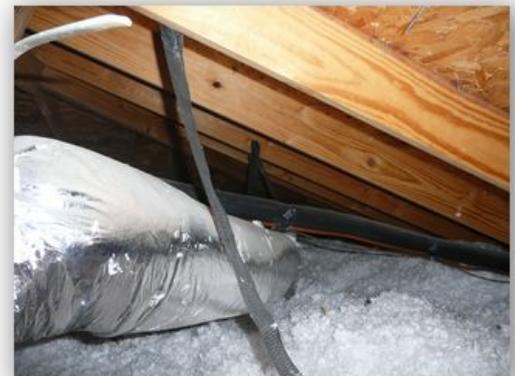
- General attic shots

- Pull-down stairs are not fire rated or fire rating could not be determined. By today's standards pull-down stairs should be fire rated in a garage location.

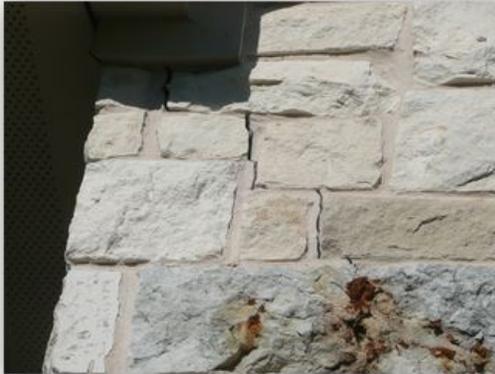
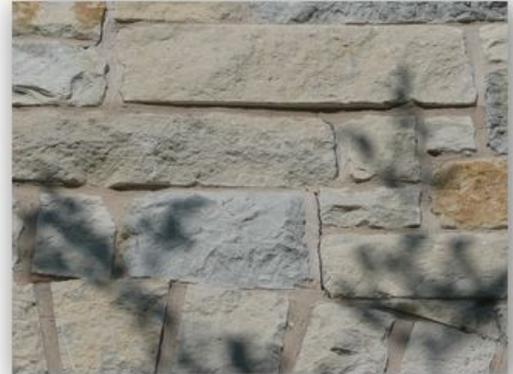
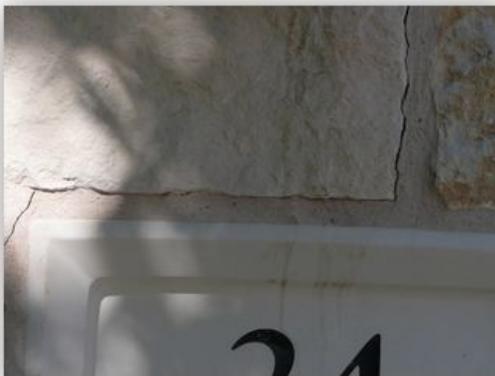
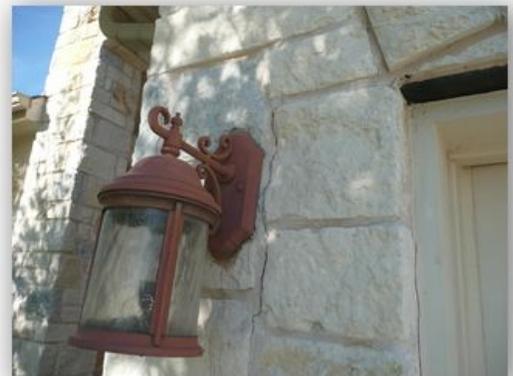
- Expansion joints were missing around doors and windows at the exterior stucco wall.
- Cracking observed above front entry and left of garage. See pictures below.

- Recommend having stone wall structure looked at above front entry and around garage.

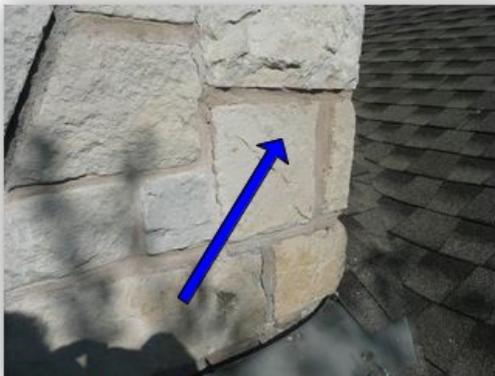
- Stone above front entry right side above the roof line was observed to be loose. See pictures below.

Stones loose on wall

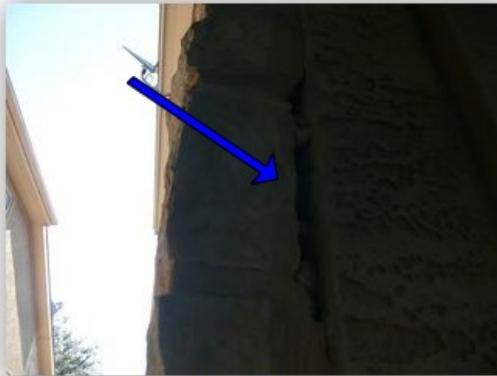
- Seal voids between stone and wall. See right rear of home for example.

Seal voids

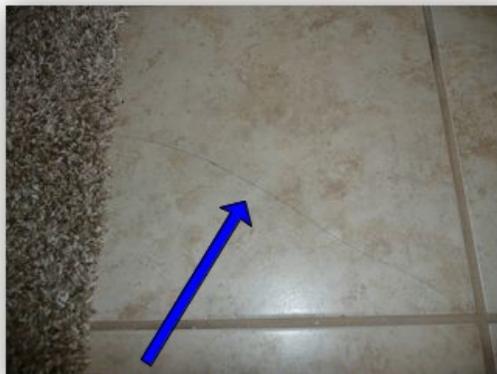
- Transference cracks were observed on the tile in one or more locations. See front entry . This is generally caused by hydration cracks at the foundation transferring to the tile. Foundation cracks should be sealed before new tiles (if any) are installed.

Transference crack

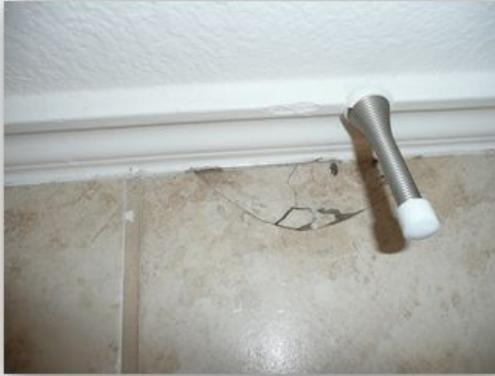
- Tile damaged at front entry. See picture below.

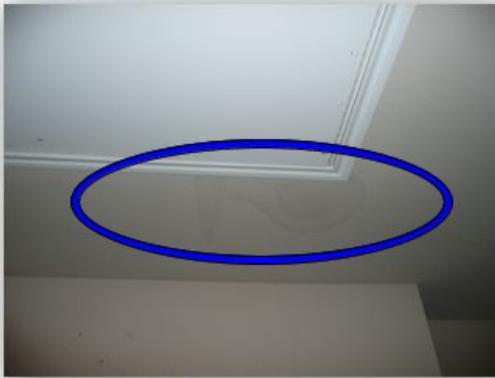
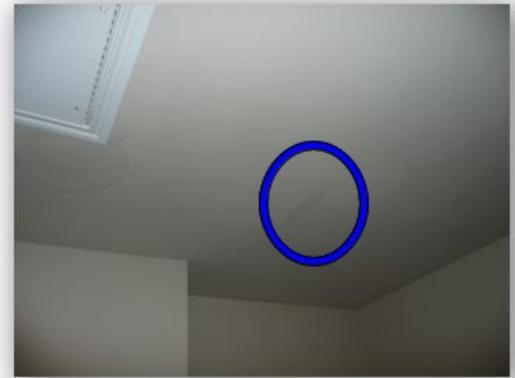
- A small sheetrock crack was observed in the ceiling of the garage .
- Previous water leak observed ceiling of the garage. Inspector did not observe any leak at time of inspection.

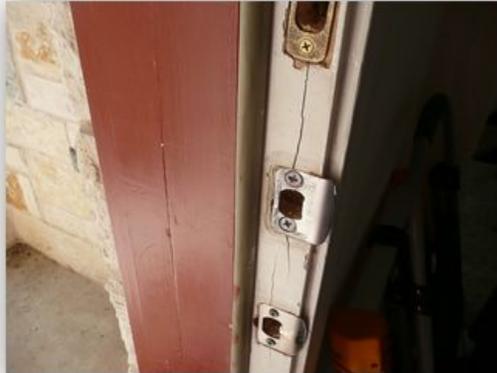
- Door jam damaged. See front door for example.

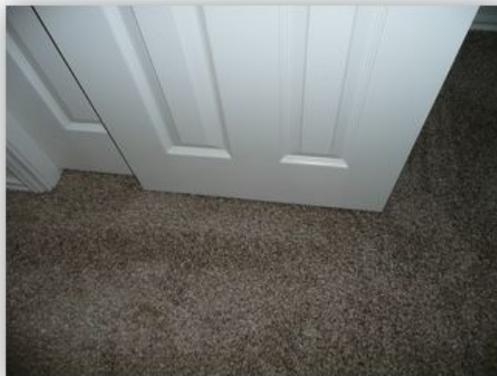
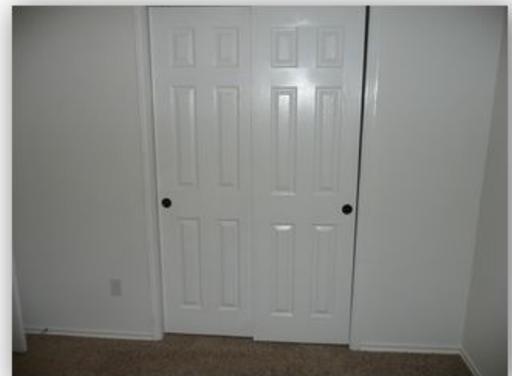
- Energy Efficiency - Weather-stripping improvements are needed at the front door, rear door . Light could be seen around the door.
- One or more door stops missing various locations.
- Closet door tracks missing. Also door needs adjusting. See downstairs bedroom for example.

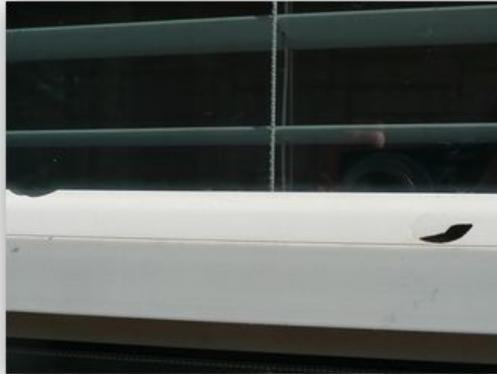
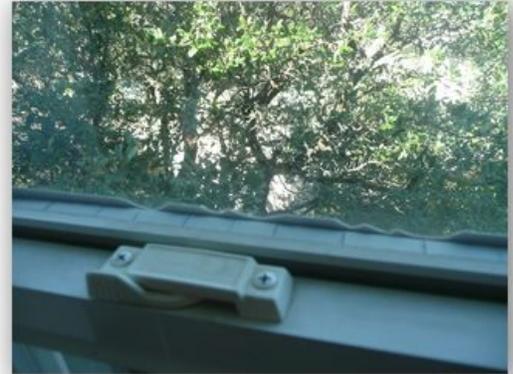
- One or more windows had exterior trim damage from likely hail. See pictures below.

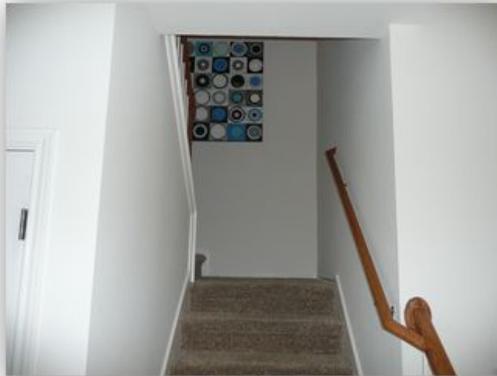
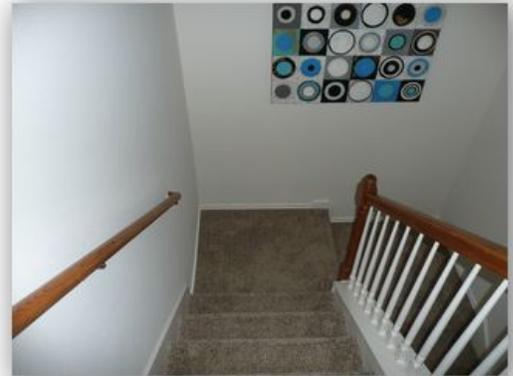
- By today's standards, the handrail at the interior staircase should be continuous over the entire length of the stairs.

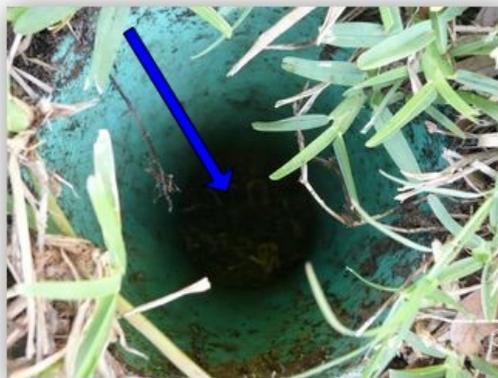
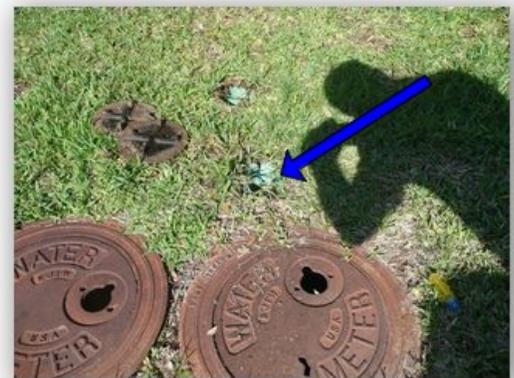
- Dirt appears to be partially covering the water cutoff near the street. Dirt should be removed to allow access to the cutoff valve.

Water cutoff

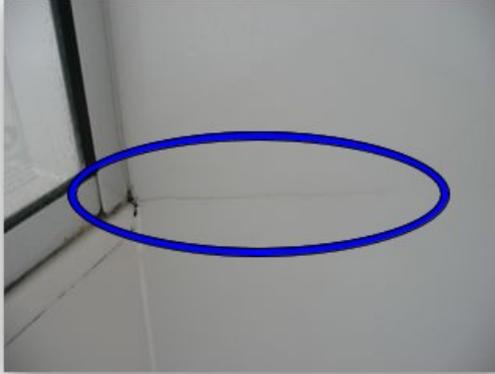
- Seal around spout master bath.
- Shower enclosure had a crack that may allow water to penetrate behind the enclosure. See picture below.

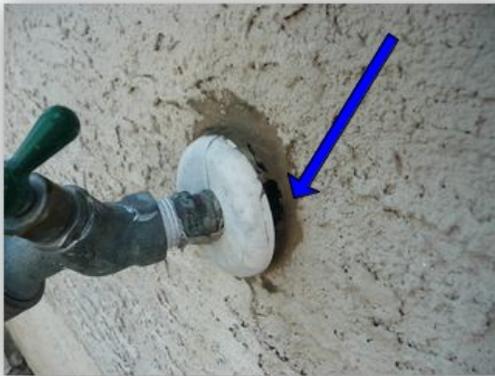
- Seal around exterior hose bibs.

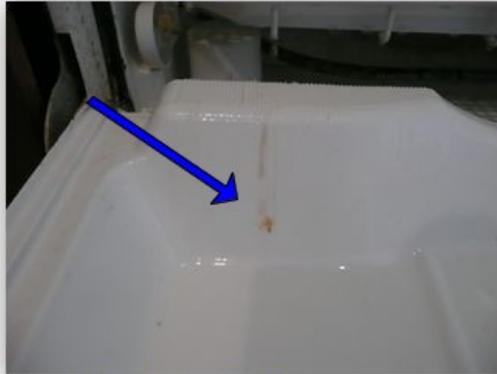
- Middle and upper spray arms not working when unit was operated. May be plugged.
- Rust was observed on the interior tub of the cabinet and/or dish racks.

Rust interior door
